**Yosemite National Park PEM Demonstration Program,  
Final Report**

Proton Exchange Membrane (PEM) Fuel Cell Demonstration  
Of Domestically Produced PEM Fuel Cells in Military Facilities

**Administrative Building,  
Yosemite Valley  
Yosemite National Park**

**November 29, 2005**

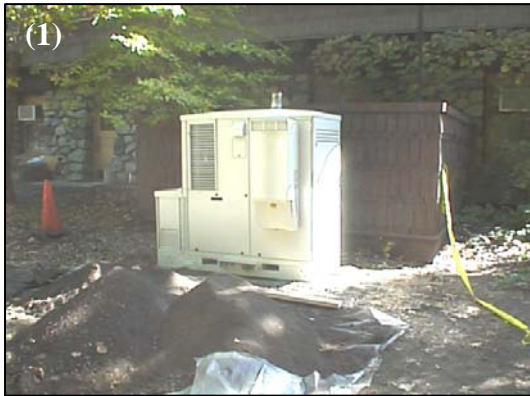
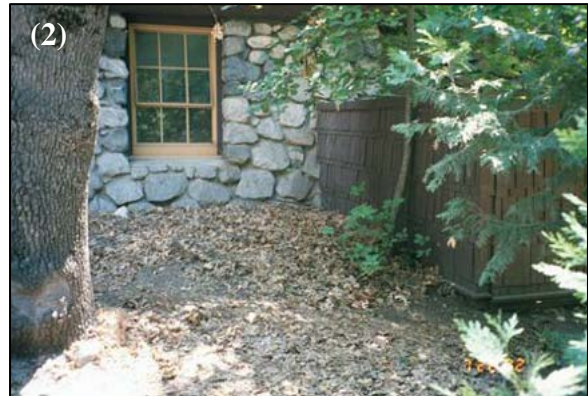
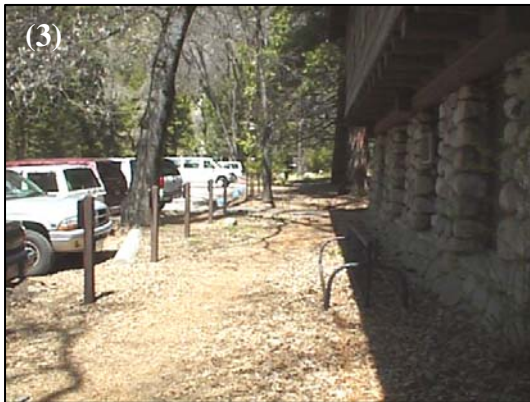
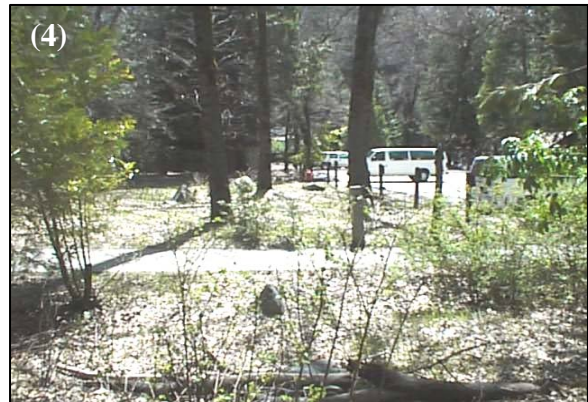
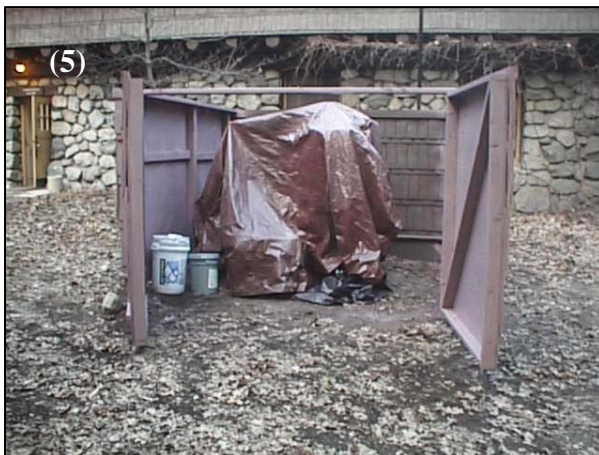
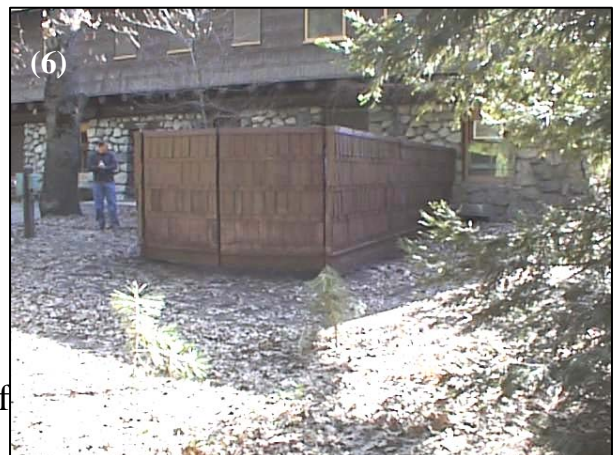
Photo (1) below shows the fuel cell on its pad adjacent to the entrance to the Park Service administration building, seen in the background. The fence behind the fuel cell encloses a diesel generator and fuel storage tank. Note the exterior shingle wall construction of the fence. This is an example of the historical accuracy that LOGAN had to replicate with the fuel cell fence, clearly seen in photo (6) below, in order to have it approved by the Park Service. The shingles on the new fence are cut from Sierra Sweet Pine trees, and were a special order from a local vendor.

Photo (2) below shows the exterior wall with a window that provides light to the mechanical room in the basement below grade. Conduit and piping runs connecting the fuel cell to electrical and mechanical interfaces had to penetrate this 12-inch granite wall just below the window. Photo (3) below shows the LP Gas supply line routing from the foot of the pad site to LP Gas tank farm. The route passed just inside the bollards that line the parking lot.

Photo (4) below depicts the same routing from the tank farm back to the fuel cell pad site. During excavation and construction of this fuel line, a Park Service Archaeologist and a Tribal Observer examined excavations and many soil samples for evidence of historic artifacts. No materials of historic significance were encountered.

Photos (5) and (6) below are shots of the site as constructed. A protective tarp covers the fuel cell in photo (5).

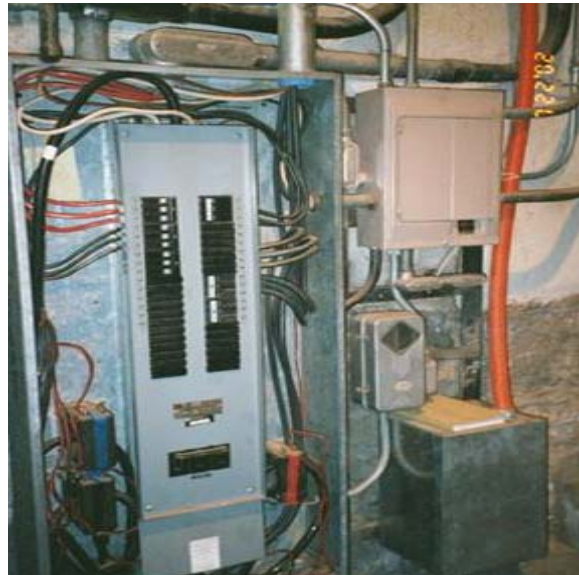
The Plug Power GenSys 5P fuel cell inverter has a power output of 110/120 VAC at 60 Hz. At this site the unit operated continuously at 2.5kW, providing power to three-phase 208 VAC circuits. In order to match the building's three-phase distribution, the fuel cell was wired to a new grid parallel/synchronous 50-amp circuit breaker in the service panel pictured to the right. It powered one phase of the three-phase circuit with approximately 30 amps service. The line diagram pictured below provides an illustration of the electrical configuration, as well as the overall installation scheme.

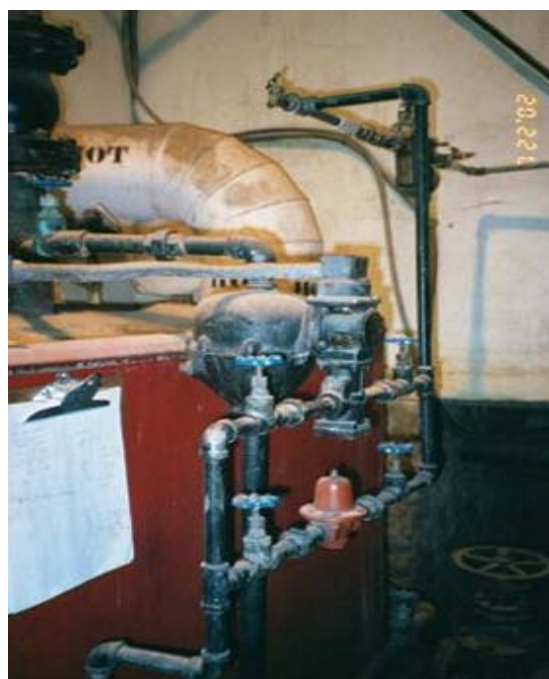
Pictured at right is the hot water boiler that is located in the basement of the Park Service administrative building. The boiler supplies hot water to coils in the building's winter heating system. The Plug Power GenSys5P internal heat exchanger provides approximately 7,800 Btu/H thermal energy at 140 degrees F. In order to capture this heat, LOGAN installed hot water supply and return piping from the fuel cell customer interface to a new shell and tube heat exchanger integrated into the boiler feed water piping. The purpose of the installation was to preheat the boiler feed water in order to reduce its demand for source fuel. Since the boiler's use is limited to seasonal space heating, there is no thermal recovery data at this point in the project.

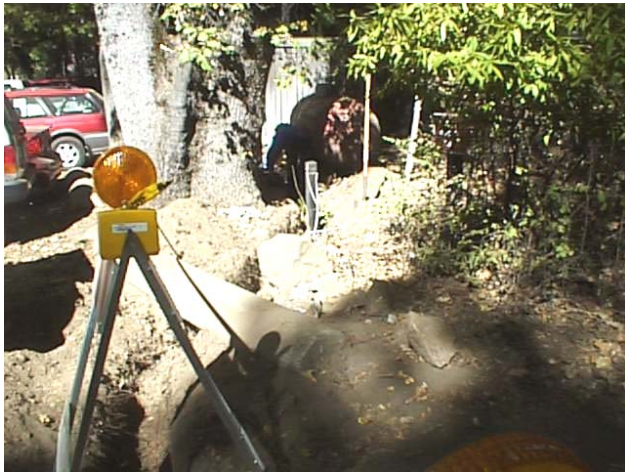
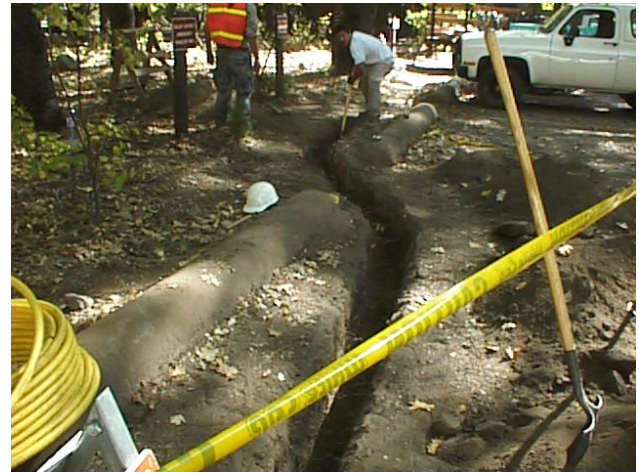
Fuel supply to the Yosemite PEM unit began with a 1000 gallon LP Gas storage tank located 300 feet west the fuel cell pad. Before entering the fuel cell inlet, the gas flows through a flow meter, which sends a flow signal to a terminal in the Web package RTU to capture and store flow data. Then a pressure regulator reduces the line pressure to 14 IWC before entering the "gas

box" section of the reformer. HD-5 LPGas is the propane variant required by the manufacturer for this product because it is rated with the highest percent propane content from among the several categories of LPGas. While operating at a set-point of 2.5 kW the Plug unit consumed 5.3 gallons LPGas per hour. At that rate, the gas storage tank needed refilling every 2 months. The photos below picture several stages of LPGas fuel line construction.

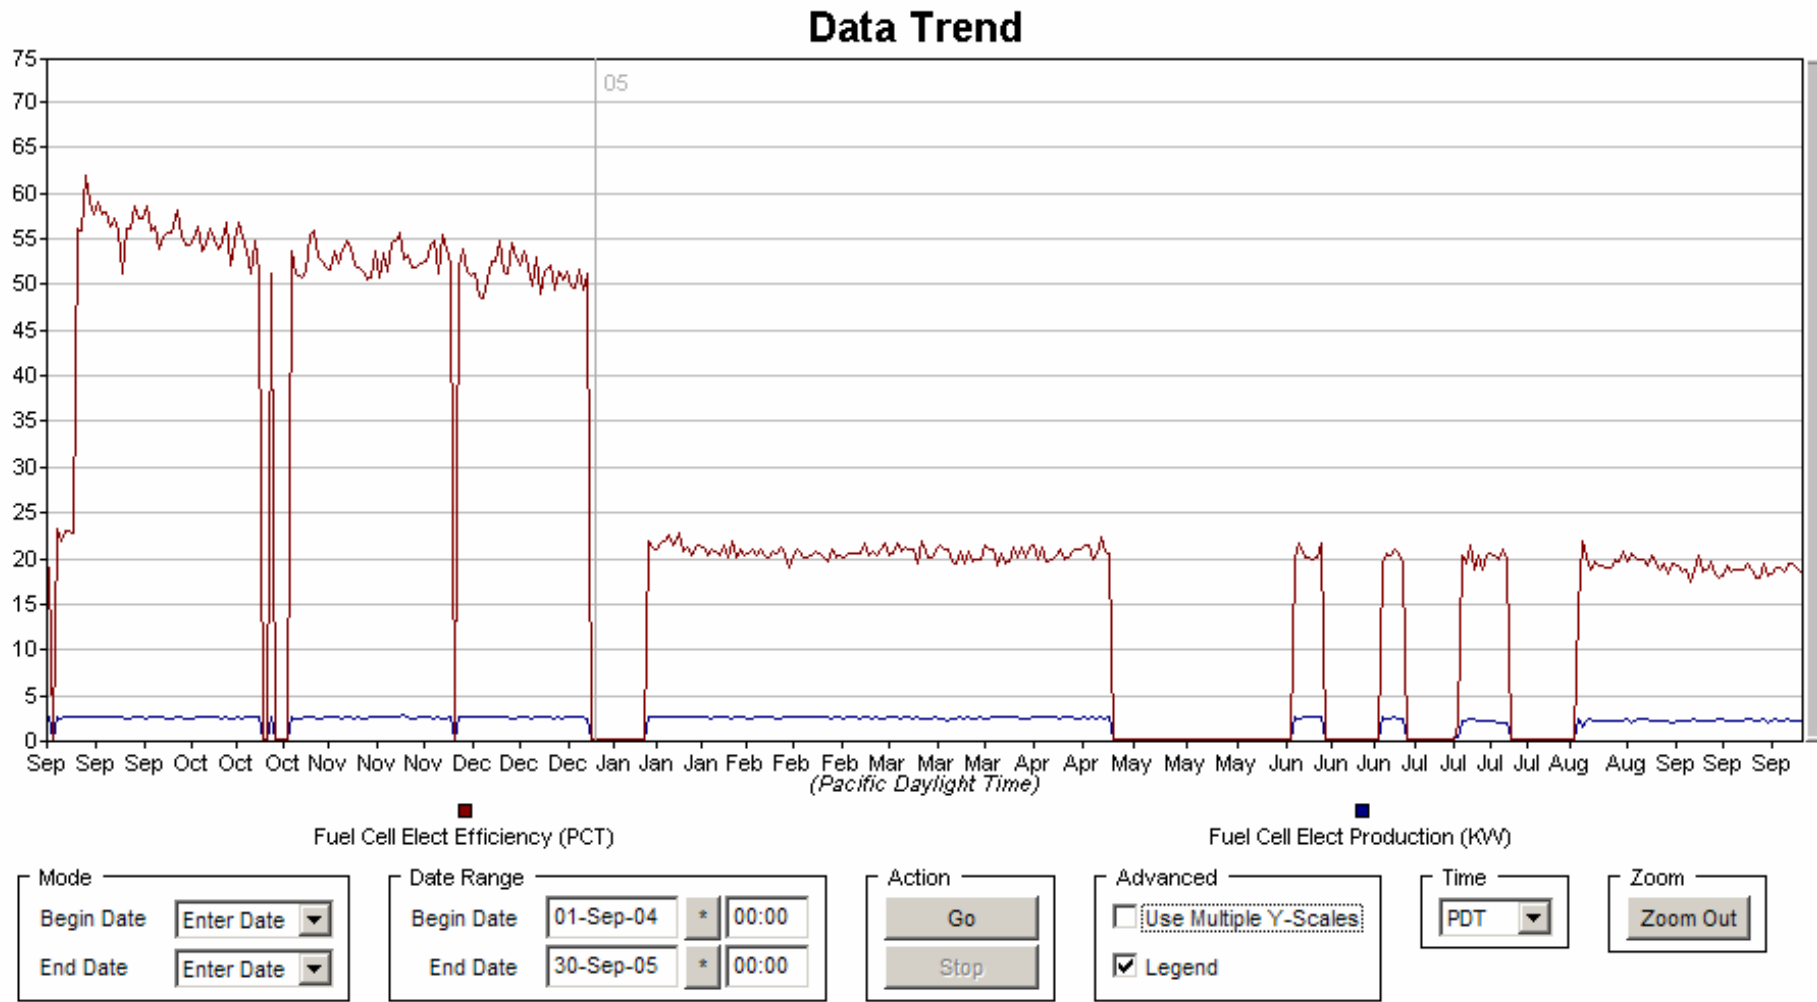
The plot compares power generation to electrical efficiency during the period Sept 2004-Sept 2005. The data during the period of September through December 2004 appears to be corrupted and overstated while the 2005 data tracks as it should.
